Flood Control Project Maintenance
2014 Structure Summary Report
Overall Unit and Item Ratings

DWR Sacramento Maintenance Yard

Flood Control Project Maintenance
Unit Cover Sheet
2014 Structure Inspection Results

**Flood Control Project Maintenance
Levee Inspections**

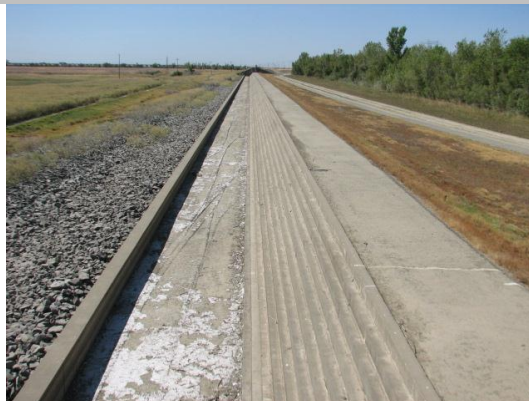
Photo 1 of 5 : ST_2014_NA0055_12_24_20140623_00006.jpg

Looking from the north side down the weir during Summer 2014.
(38.687317 -121.673711)

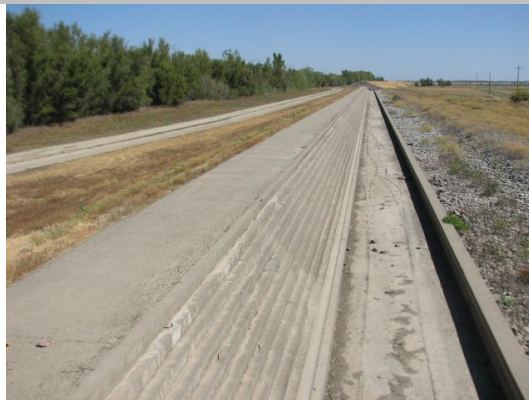
Photo 2 of 5 : ST_2014_NA0055_12_24_20140623_00007.jpg

Looking from the south end of the weir during Summer 2014.
(38.682438 -121.672924)

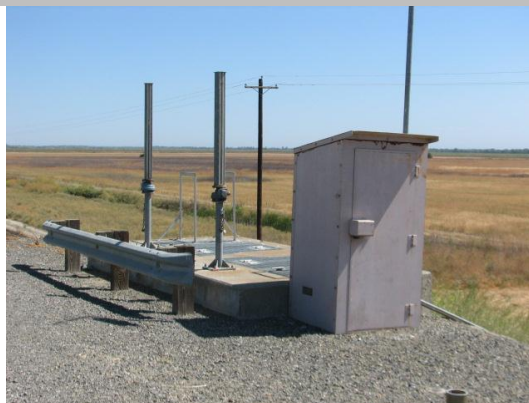
Photo 3 of 5 : ST_2014_NA0055_12_24_20140623_00008.jpg

View of the control structure on the crown during summer 2014.

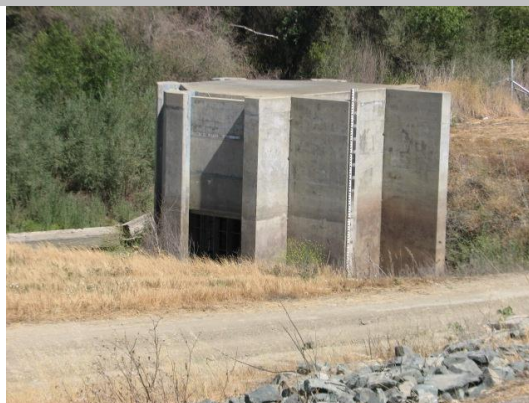
Photo 4 of 5 : ST_2014_NA0055_12_24_20140623_00009.jpg

View of the inlet structure and stop logs during Summer 2014

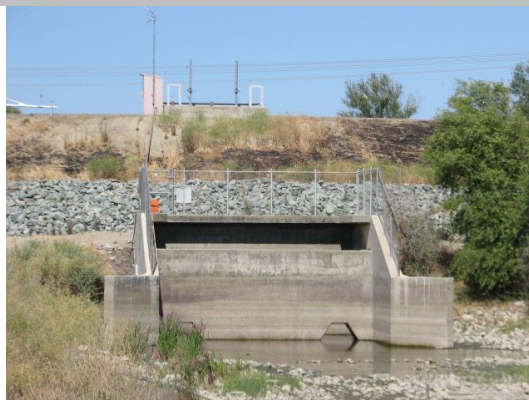
Photo 5 of 5 : ST_2014_NA0055_12_24_20140623_00010.jpg

View of the outlet structure with control structure at the crown during Summer 2014.

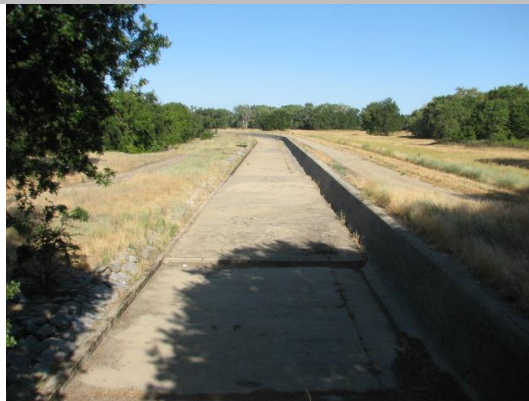
Photo 1 of 7 : ST_2014_NA0055_2_24_20140623_00007.jpg

A view looking from top of the eastside of the weir. Summer 2014 (38.764634, -121.635437)

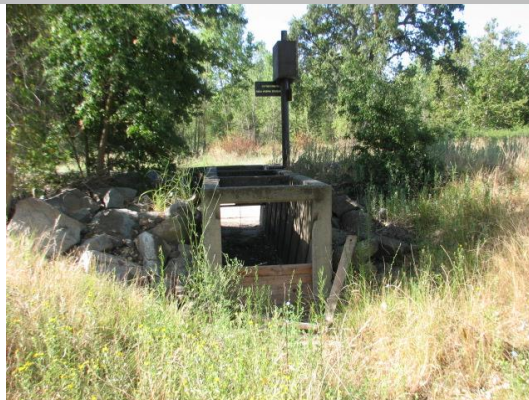
Photo 2 of 7 : ST_2014_NA0055_2_24_20140623_00008.jpg

Looking at the inlet of the fish ladder. Summer 2014 (38.764361, -121.646868)

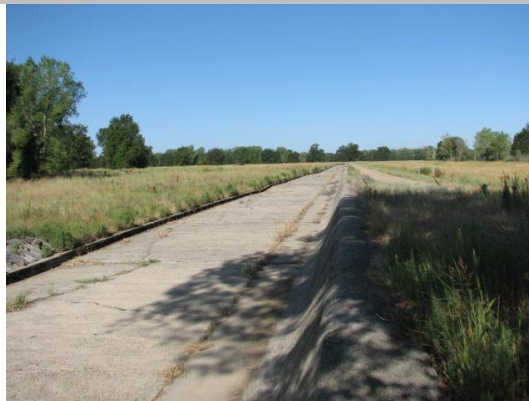
Photo 3 of 7 : ST_2014_NA0055_2_24_20140623_00009.jpg

Looking to the west from the fish ladder. Summer 2014

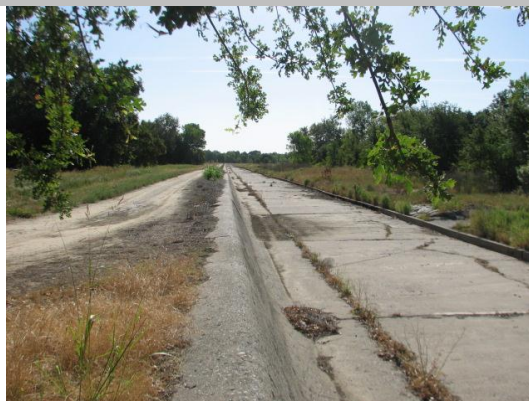
Photo 4 of 7 : ST_2014_NA0055_2_24_20140623_00010.jpg

Looking to the east from the fish ladder. Summer 2014

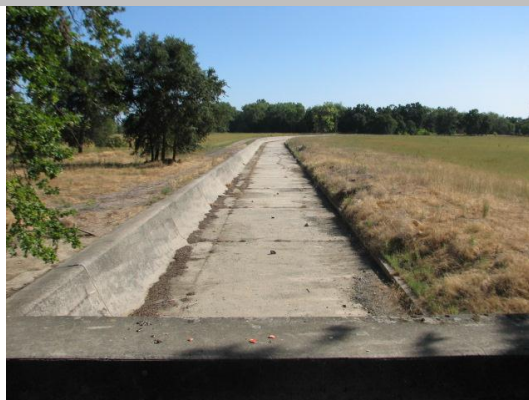
Photo 5 of 7 : ST_2014_NA0055_2_24_20140623_00011.jpg

The view is from the west end of the weir. Summer 2014 (38.758909, -121.665548)

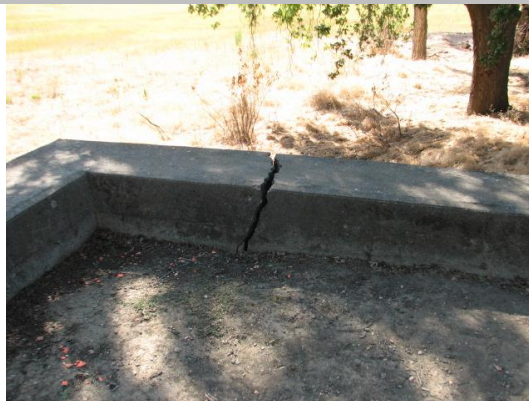
Photo 6 of 7 : ST_2014_NA0055_2_24_20140623_00012.jpg

Looking at the top wall the crack is about 1" wide. Summer 2014

LM Start	0.00	Rating **	A	Issue No.	15
LM End	0.00	Issue Type +	Ma	Location *	CR
Category	Structures & Concrete Lined Channels			GPS Latitude/Longitude	
				Start	End
Item	Concrete Surfaces			38.758880 °	38.764680 °
				-121.665380 °	-121.635430 °
DWR ID	DWR_NA0055_2_t_2012_15				
Action/Comments					
Inspector Comments: Crack runs from the top to the bottom on the downstream side at the West end of the weir. The crack appears to be about 1" at the top of the wall and about 1/2" near the bottom. This does not affect the function of the weir. It is minor but needs to be repaired. (see photo in photo documentation)

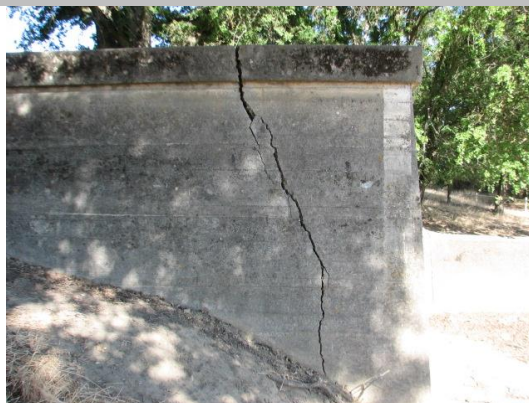
Photo 7 of 7 : ST_2014_NA0055_2_24_20140623_00013.jpg

View of the crack runs down the entire wall. Summer 2014

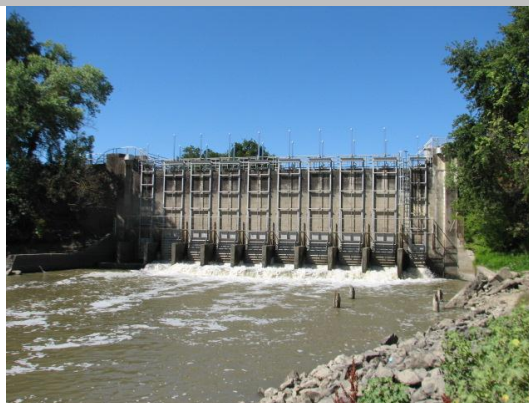
Photo 1 of 5 : ST_2014_NA0055_41_1_20140623_00005.jpg

A current view of the outlet side of the structure with all open gates.
Summer 2014

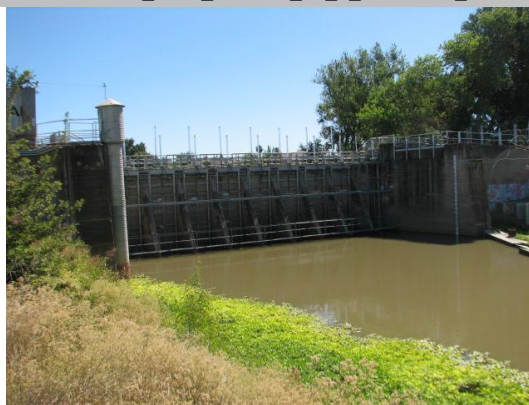
Photo 2 of 5 : ST_2014_NA0055_41_1_20140623_00006.jpg

A current view of the inlet side of the structure. Summer 2014

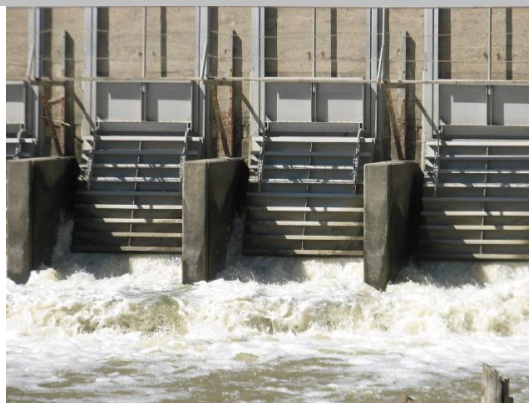
Photo 3 of 5 : ST_2014_NA0055_41_1_20140623_00007.jpg

A closeup of the flap gates on the structure. Summer 2014

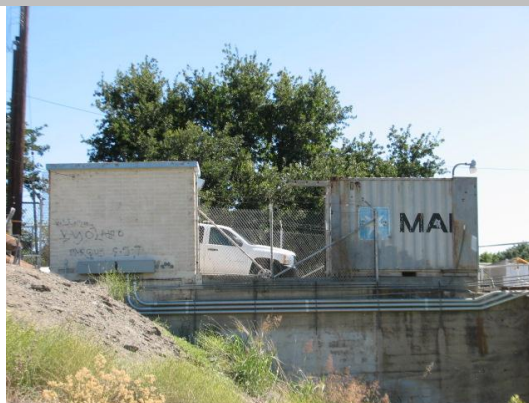
Photo 4 of 5 : ST_2014_NA0055_41_1_20140623_00008.jpg

A view of the control room and tool room. Summer 2014

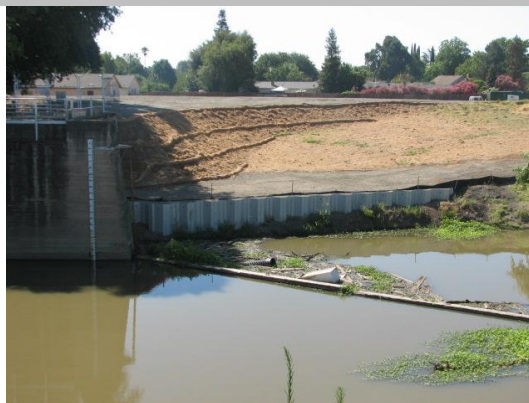
Photo 5 of 5 : ST_2014_NA0055_41_1_20140616_00004.jpg

A new landing has been established for clearing debris from the stop logs. Summer 2013

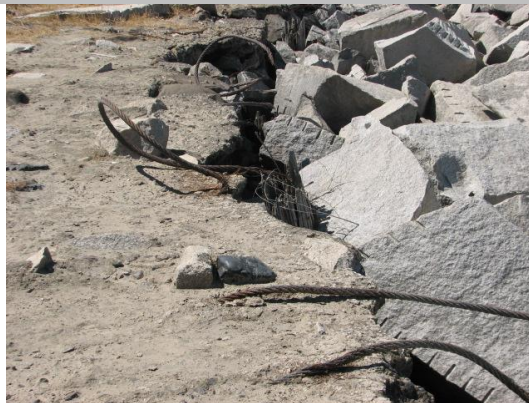
Photo 1 of 3 : ST_2014_NA0055_52_24_20140616_00001.jpg

Cable sticking out from the dam and could be a hazard. The cables have been cut off to the surface of the dam. (photo taken 2013) Small pieces of wire cable left sticking out of surface. (Inspection 2014.)

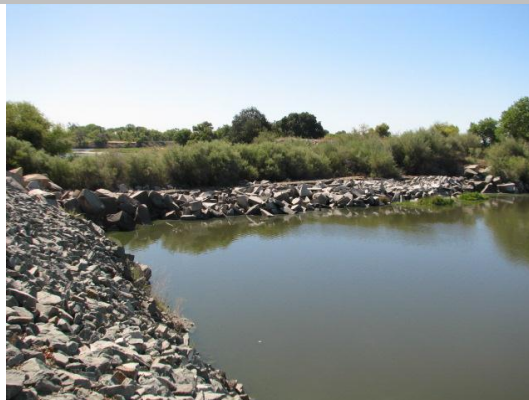
Photo 2 of 3 : ST_2014_NA0055_52_24_20140619_00004.jpg

The photo is of the backside looking towards river. Summer 2014

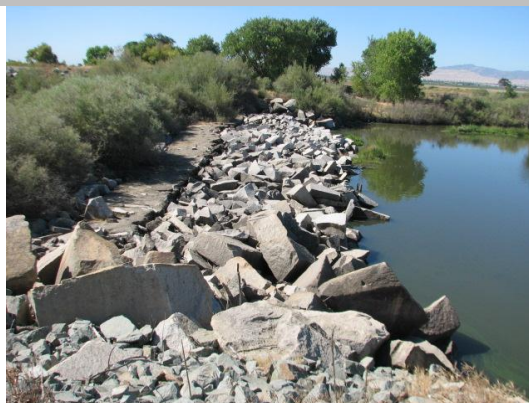
Photo 3 of 3 : ST_2014_NA0055_52_24_20140619_00005.jpg

Looking across the dam and the vegetation on the river side of the dam.
Summer 2014

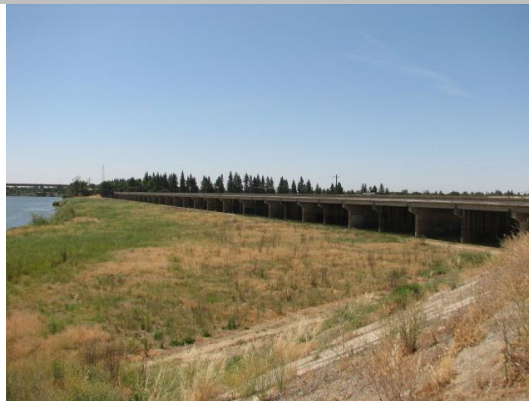
Photo 1 of 9 : ST_2014_NA0055_1_24_20140623_00001.jpg

A current view of the inlet side of the structure. Summer 2014

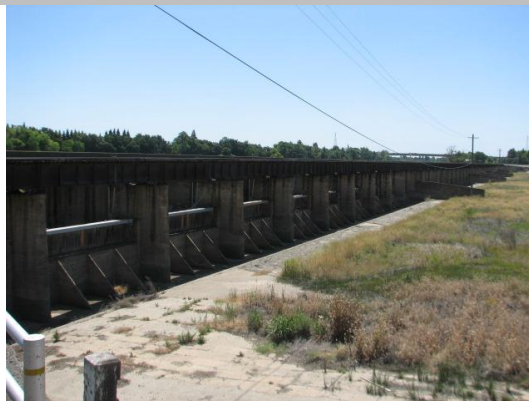
Photo 2 of 9 : ST_2014_NA0055_1_24_20140623_00002.jpg

Looking from the northside of bypass. A view of the outlet side. Summer 2014 (38.607156 -121.560092)

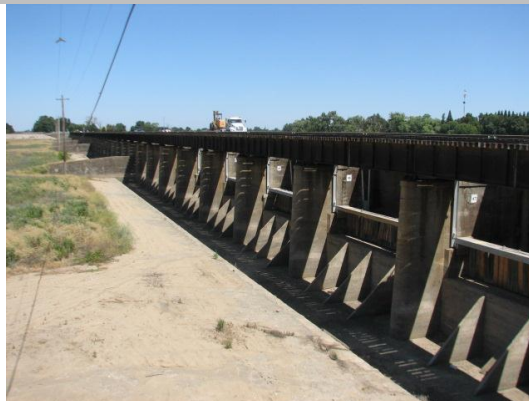
Photo 3 of 9 : ST_2014_NA0055_1_24_20140623_00003.jpg

The view of the outlet side is from the southside of the bypass. Summer 2014 (38.60281 -121.555783)

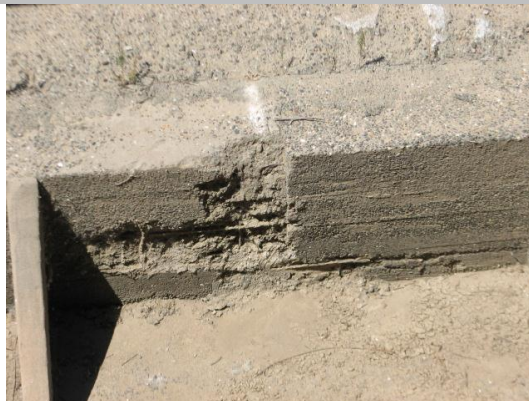
Photo 4 of 9 : ST_2014_NA0055_1_24_20140623_00004.jpg

(Bay 14) Rebar is exposed on the defusion wall. Summer 2014

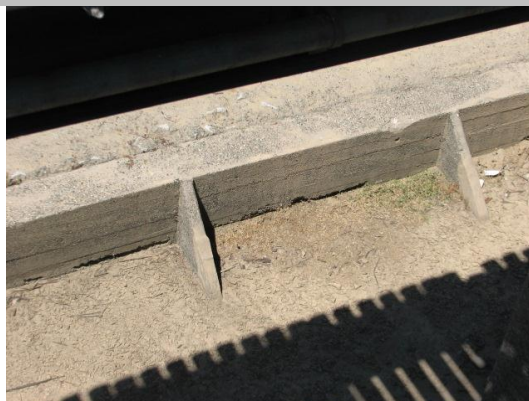
Photo 5 of 9 : ST_2014_NA0055_1_24_20140623_00005.jpg

(Bay 12) A small amount of scouring at the base of the wall. Summer 2014

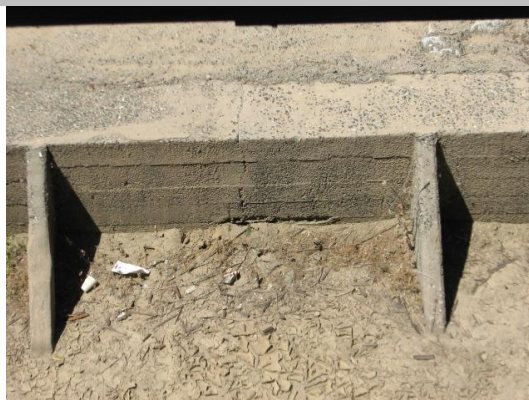
Photo 6 of 9 : ST_2014_NA0055_1_24_20140623_00006.jpg

(Bay11) A small amount of scouring at the base of the wall. Summer 2014

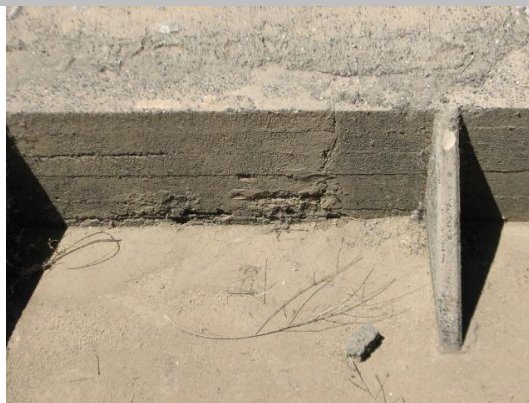
Photo 7 of 9 : ST_2014_NA0055_1_24_20140623_00007.jpg

(Bay 6) Scouring on the defusion wall. Summer 2014

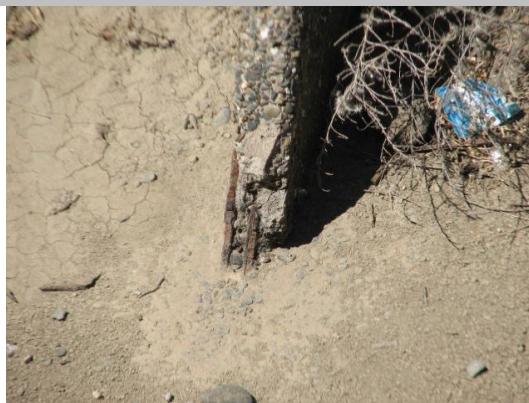
Photo 8 of 9 : ST_2014_NA0055_1_24_20140623_00008.jpg

(Bay3) Some rebar is exposed. Summer 2014

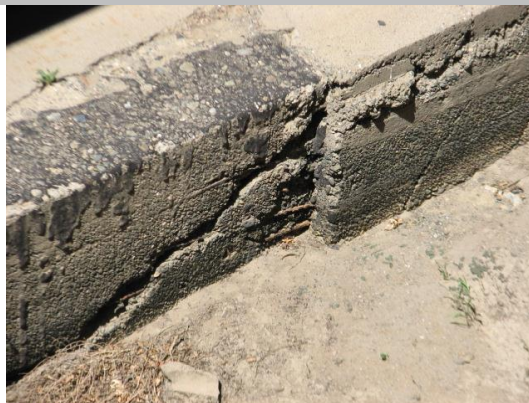
Photo 9 of 9 : ST_2014_NA0055_1_24_20140623_00009.jpg

(Bay1) Small cracking and rebar is exposed. Summer 2014
